Case history

TDM 2 helps diagnose a crack on a charge gas compressor

by Fabio H. G. Martins
Maintenance Engineer
Petroquímica União S.A.
and
Rolando G. Dias
Manager/MDS Engineer
Bently do Brasil Ltda.

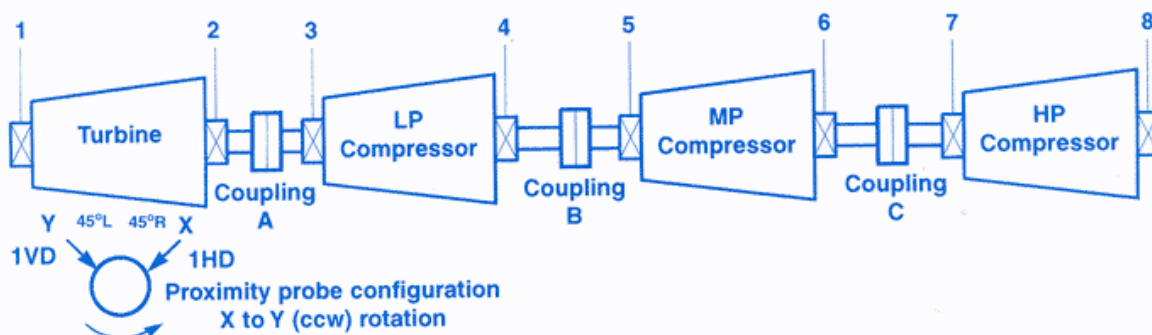
Figure 1
Machine train diagram.

The couplings are gear type, so the power is transmitted between rotors by gear teeth. Small axial displacements, due to load variation and thermal expansion,

sion, as well as residual misalignment, are absorbed by the couplings.
